Flight Service Evaluation of
Kevlar-49 Epoxy Composite
Panels in Wide-Bodied
Commercial Transport
Aircraft - Fourth Annual
Flight Service Report

LOCKHEED-CALIFORNIA COMPANY
BURBANK, CA 91520

CONTRACT NAS 1-11621

April 1978

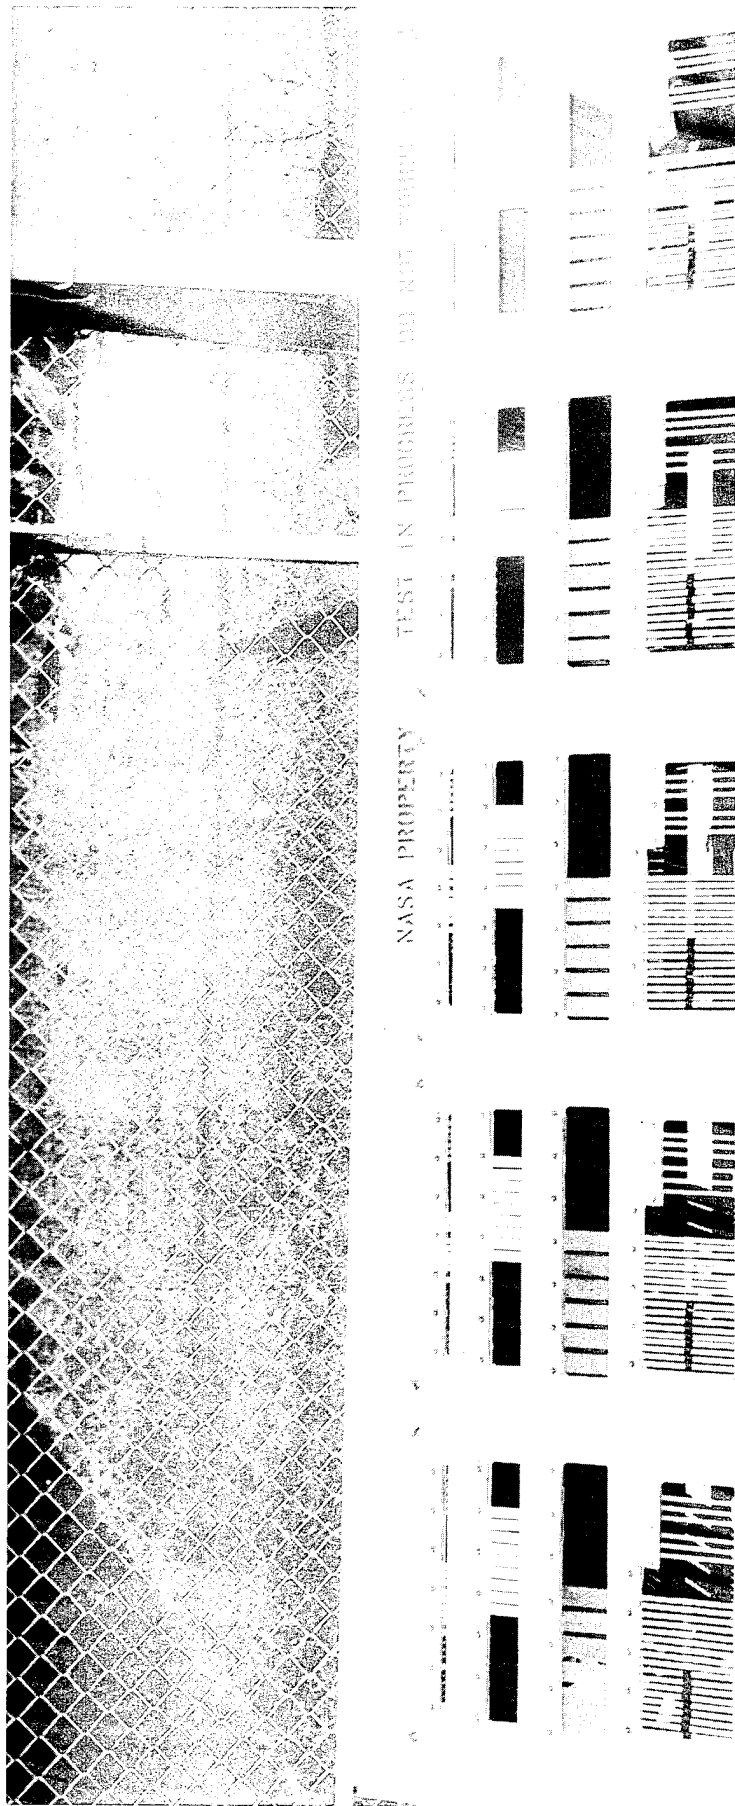
Figure 1. Rack for Holding Environmental Test Specimens

Environmental exposure data are being obtained on interlaminar shear, flexure, and compression specimens. A rack designed to hold five replicate panels is shown in Figure 1. The Kevlar/epoxy specimens are held in the panels in a manner that provides a maximum exposure to sunlight on one surface but allows free circulation of air around the specimens. Panels for 1 and 3 years exposure data have been removed and the specimens have been tested. The remaining 3 panels are scheduled for removal after 5, 7, and 10 years, respectively. Data being generated include strength retention, moisture pickup, and ultraviolet weight loss.

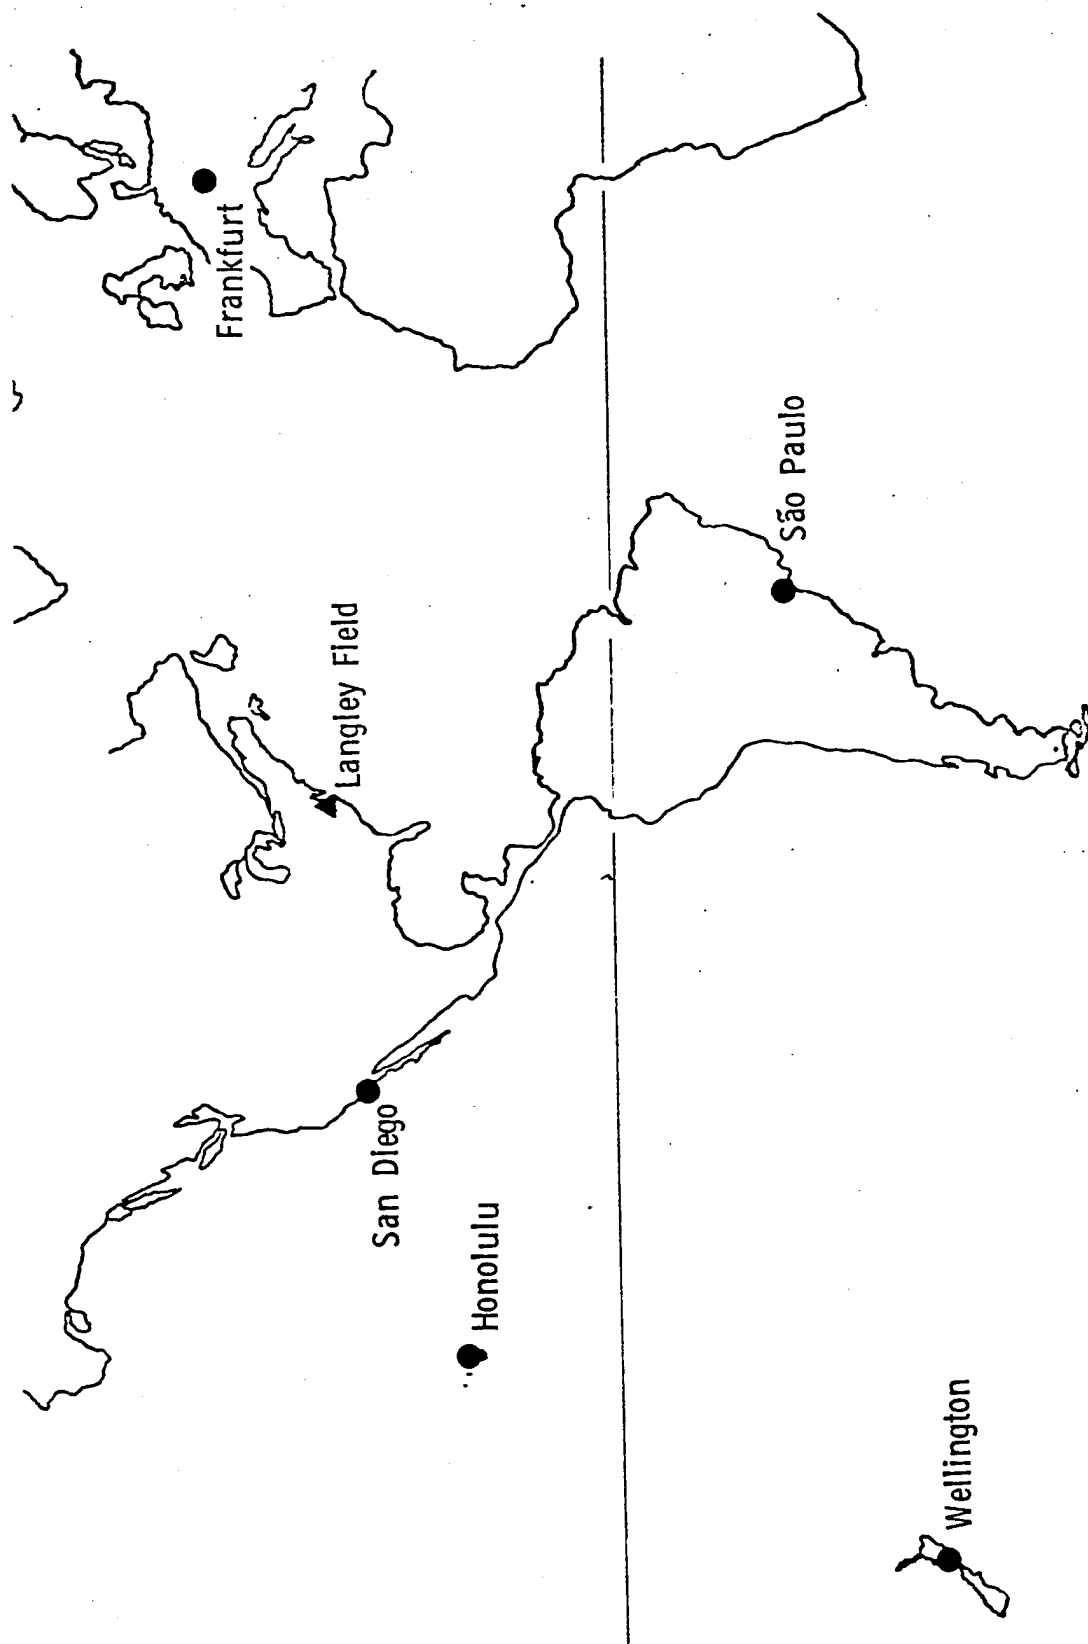
Figure 2. Worldwide Distribution of Environmental Exposure Racks

Figure 2 shows the worldwide distribution of the environmental exposure racks. The average annual temperature and relative humidity for all exposure sites are 290K (62°F) and 75 percent, respectively. Figure 3 shows the moisture pickup data for Kevlar-49/F-155 and Kevlar-49/F-161 flexure specimens after 1 and 3 years exposure. The data shown is for all exposure sites except for the 3 year Brazil data which is not currently available. The average moisture pickup after three years exposure is 2.1 percent for the 450K (350°F) cure Kevlar-49/F-161 system and 1.9 percent for the 394K (250°F) cure Kevlar-49/F-155 system. Figure 4 shows the weight loss data resulting from 3 years outdoor ultraviolet exposure for all exposure sites except Brazil. The exposed surface dimensions for the flexure specimens was 2.54 cm x 6.48 cm (1.00 in. x 2.55 in.). The weight loss data are presented as a function of exposure site latitude. The ultraviolet weight loss varies from 1.5 mg/cm² for the Kevlar-49/F-161 material at the Germany rack location to 7.9 mg/cm² for the Kevlar-49/F-155 material at the Hawaii rack location. The limited data obtained to date indicates that weight loss due to ultraviolet exposure is approximately inversely proportional to the distance of the exposure site from the equator. The weight loss of 7.9 mg/cm² represents about 25 percent of the weight of one ply for the 3.17 mm (.125 in.) thick flexure specimens. Table 1 lists the moisture pickup and ultraviolet weight loss data presented in Figures 3 and 4. It should be pointed out that all the specimens had bare surfaces. Preliminary data from other tests indicate that standard commercial aircraft paint practically eliminates ultraviolet weight loss of composite laminates. However, the paint does not prevent moisture absorption.

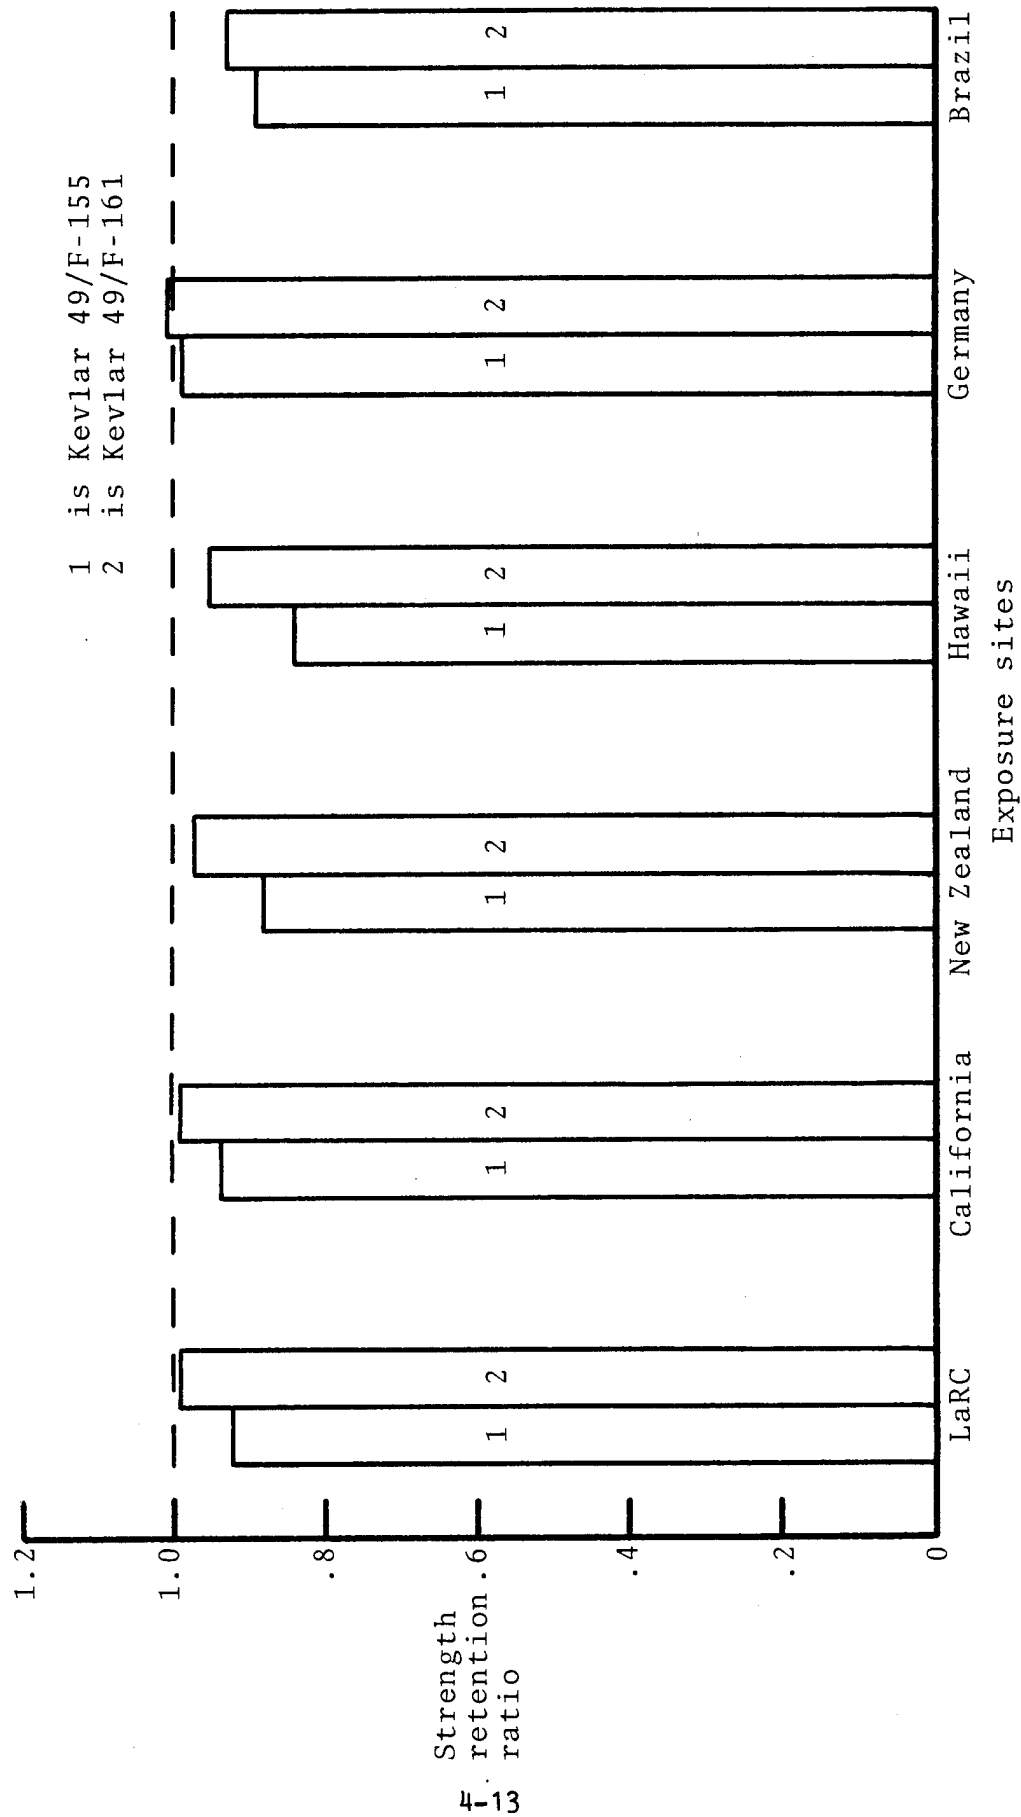
Figure 6. RT Flexure Strength Retention of Kevlar/Epoxy After 3 Years
Outdoor Ground-Based Exposure

strength retention for the Kevlar-49/F-155 Hawaii specimens is shown in Figure 6. Very little strength changes have occurred for the Kevlar-49/F-161 flexure specimens after 3 years exposure at all six locations as shown in Figure 6.

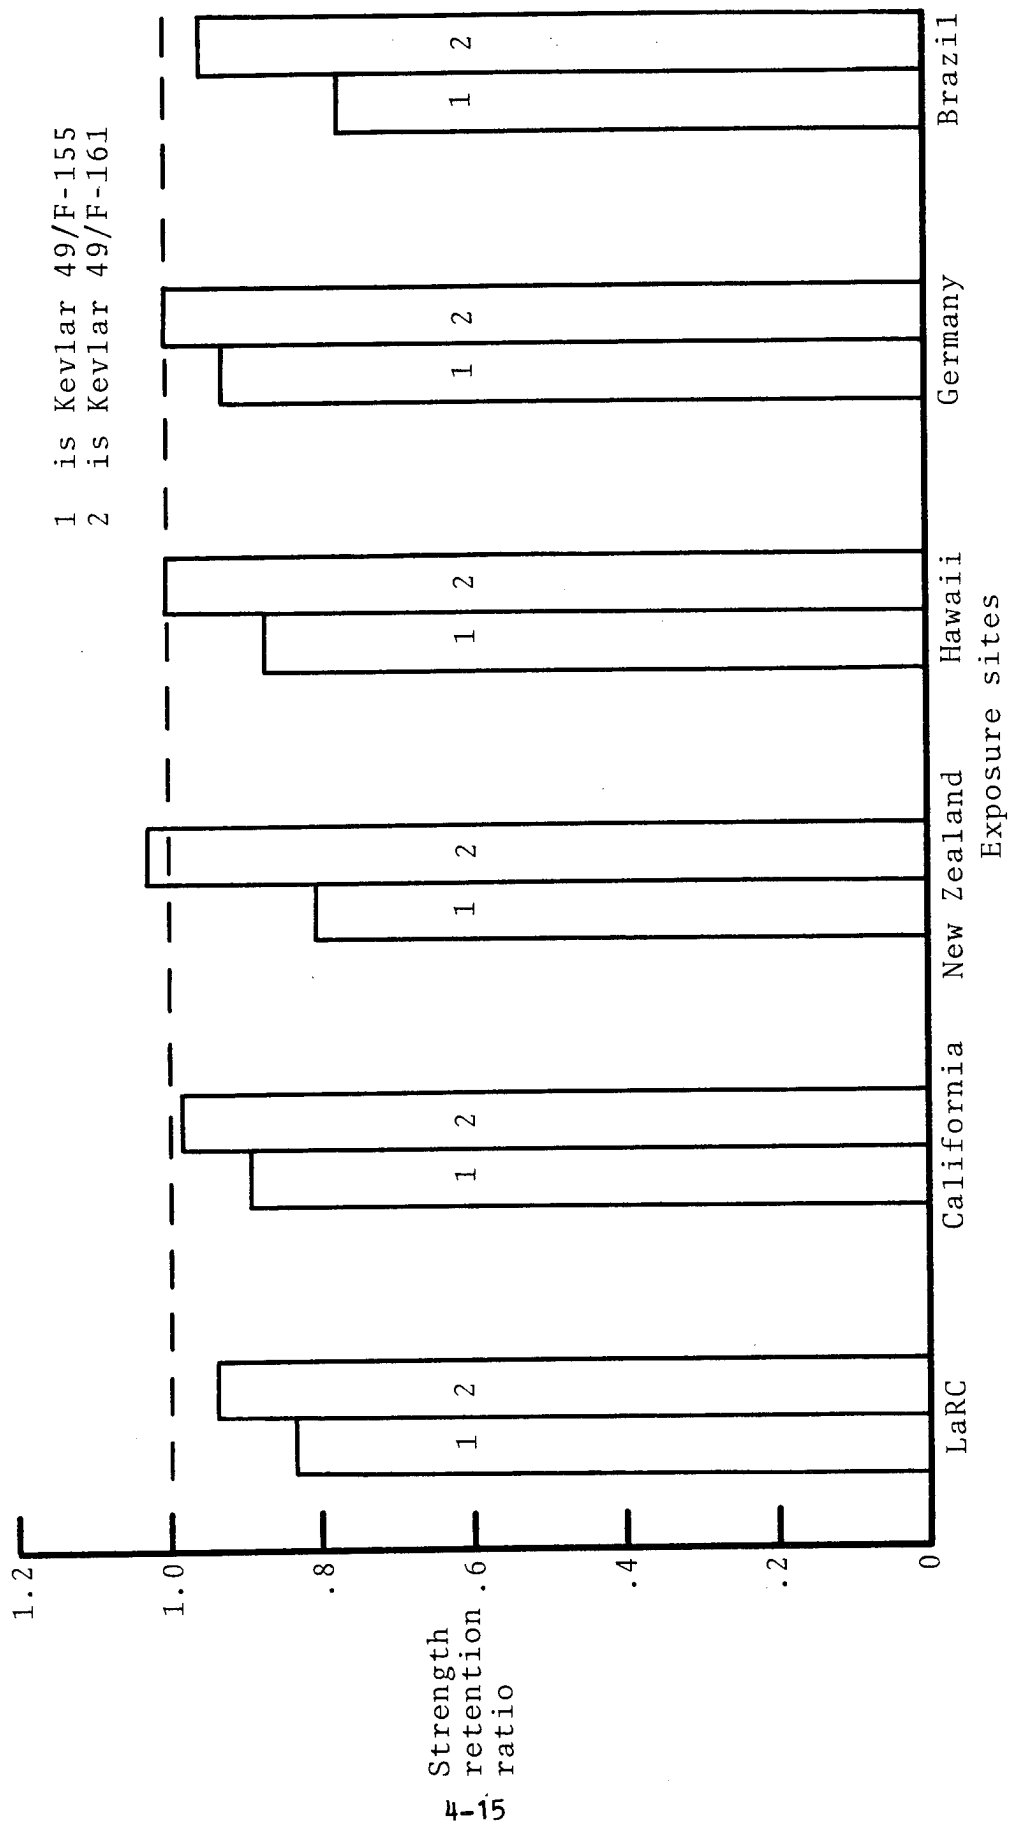
Figure 8. RT Shear Strength Retention of Kevlar/Epoxy After 3 Years
Outdoor Ground-Based Exposure

The largest short beam interlaminar shear strength reduction occurred after 3 years exposure in Brazil. A 76 percent strength retention for the Kevlar-49/F-155 Brazil specimens is shown in Figure 8. The largest strength reduction for the Kevlar-49/F-161 shear specimens occurred after 3 years exposure at the Langley Research Center. This strength reduction was only about 6 percent.

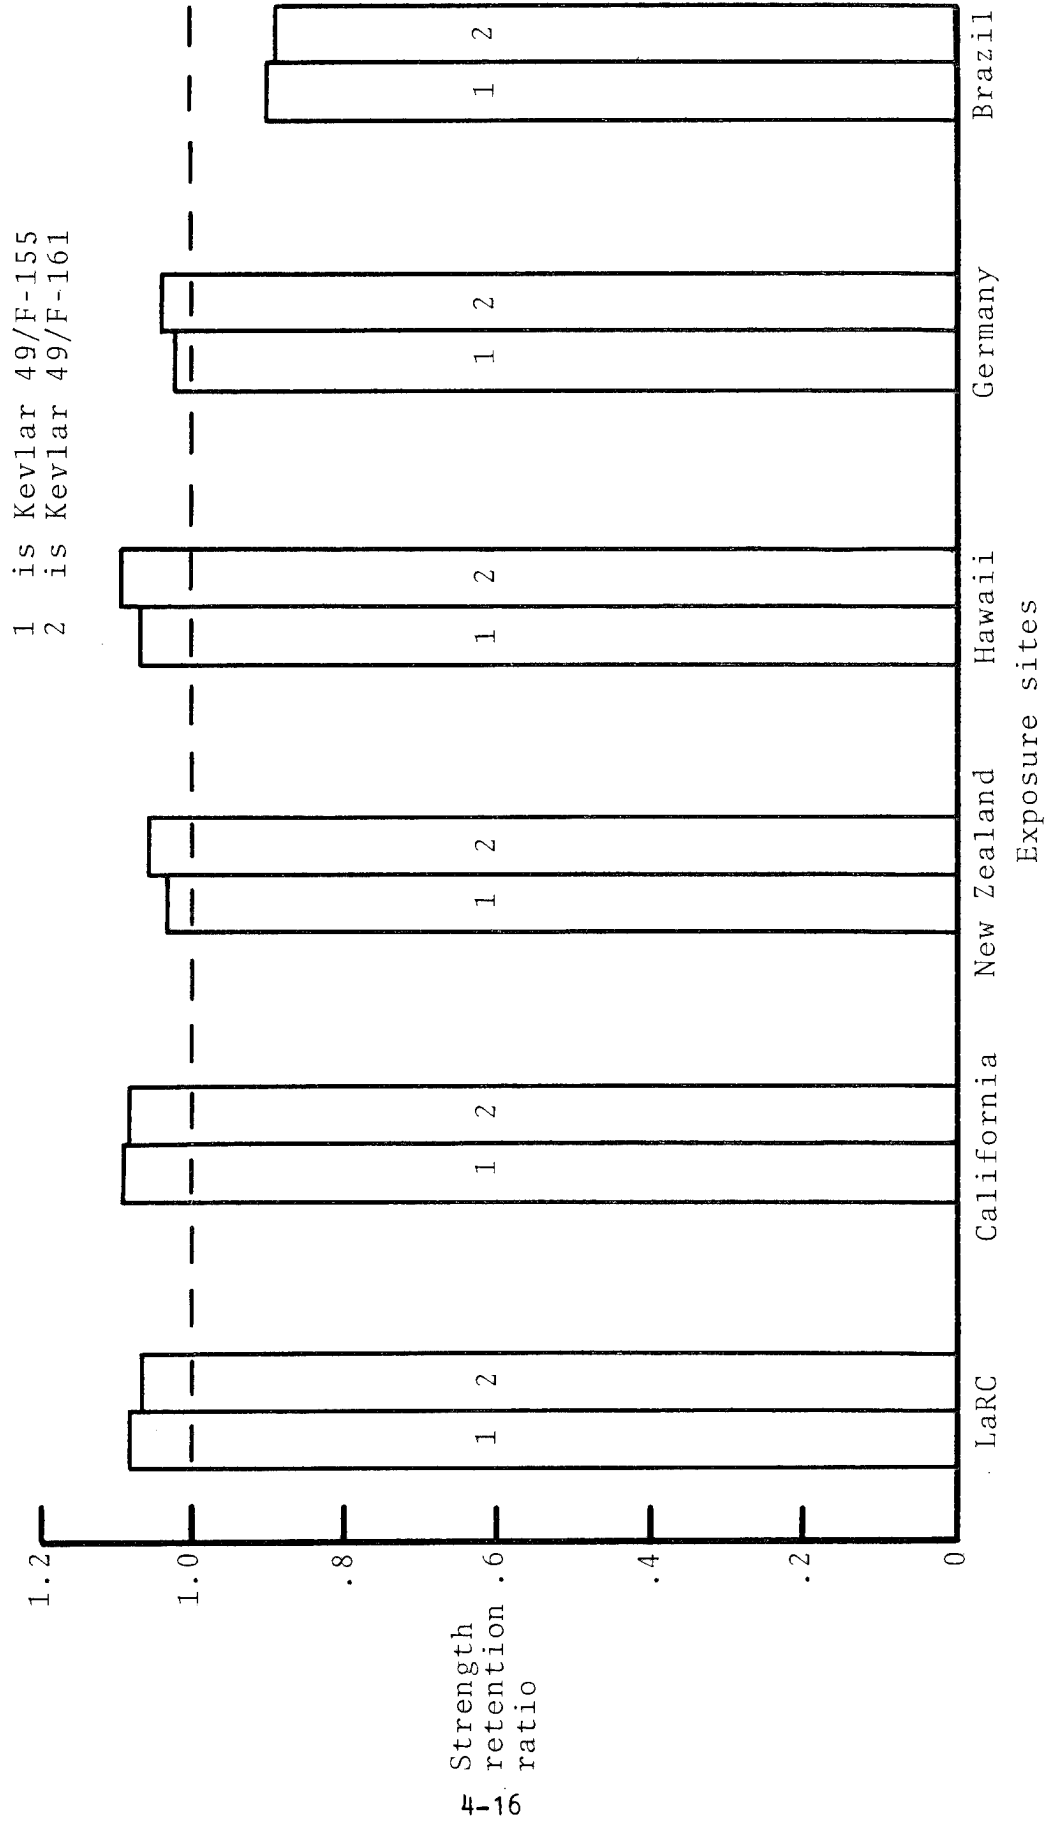
Figure 9. RT Compressive Strength Retention of Kevlar/Epoxy After 1 Year Outdoor Ground-Based Exposure

The 1 year compression strength increased compared to the baseline except for the specimens exposed in Brazil which showed a 10 percent strength reduction as shown in Figure 9. The 3 year compression strength decreased except for the specimens exposed in Brazil which showed a 2 to 4 percent strength increase compared to the baseline specimens as shown in Figure 10. Scatter in the data and a limited number of tests are probably the cause of variations in data trends.
